# Seismic Isolation Retrofitting of the Main Building and Prefectural Assembly Building of the Nagano Prefectural Government: High-Performance Seismic Isolation on Two Large-Scale Government Buildings

Satoru Nagase, Nikken Sekkei	Hiroshi Yamamoto, Nikken Sekkei	Hideyuki Hayashi, Nikken Sekkei	Yoshisato Esaka, Nikken Sekkei	Hiroaki Matsuura, Kajima Corporation	Yuji Takahashi, Shimizu Corporation
---------------------------------	---------------------------------------	---------------------------------------	--------------------------------------	---	---

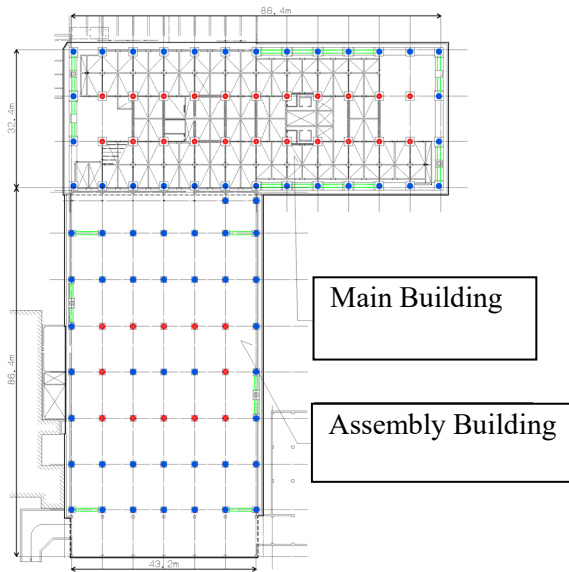
Fig. 2. Summary of seismic isolation members (top: Main Building; bottom: Assembly Building)

Supporting a load of 12 stories including a penthouse, the pillars are subject to high maximum long-term axial force of 12,000 kN. Immediately beneath all 52 pillars, natural rubber with a diameter of 900 mm and laminated rubber isolators containing lead plugs with a diameter of 1,100 mm were placed in a well-balanced arrangement (Fig. 2, top). In addition, oil dampers were placed as separate attenuation materials. Through the effective use of viscous damping, the plan addressed the two conflicting challenges of minimizing response of the superstructure and reducing the amount of response deformation of base

This building provides large spaces that are used as an assembly hall and auditorium, and the pillar axial force is not uniform throughout. Therefore, careful thought was given to the arrangement of isolators and damping materials, with the aim of constructing a base isolation layer with no torsion. By placing oil dampers on the outer periphery of the building, the plan was effective in reducing dynamic torsion. The seismic isolation members used are the same types as those of the Main Building, and the isolators are 700 mm in diameter, considering pillar axial force and the amount of seismic isolation deformation (Fig 2, bottom).

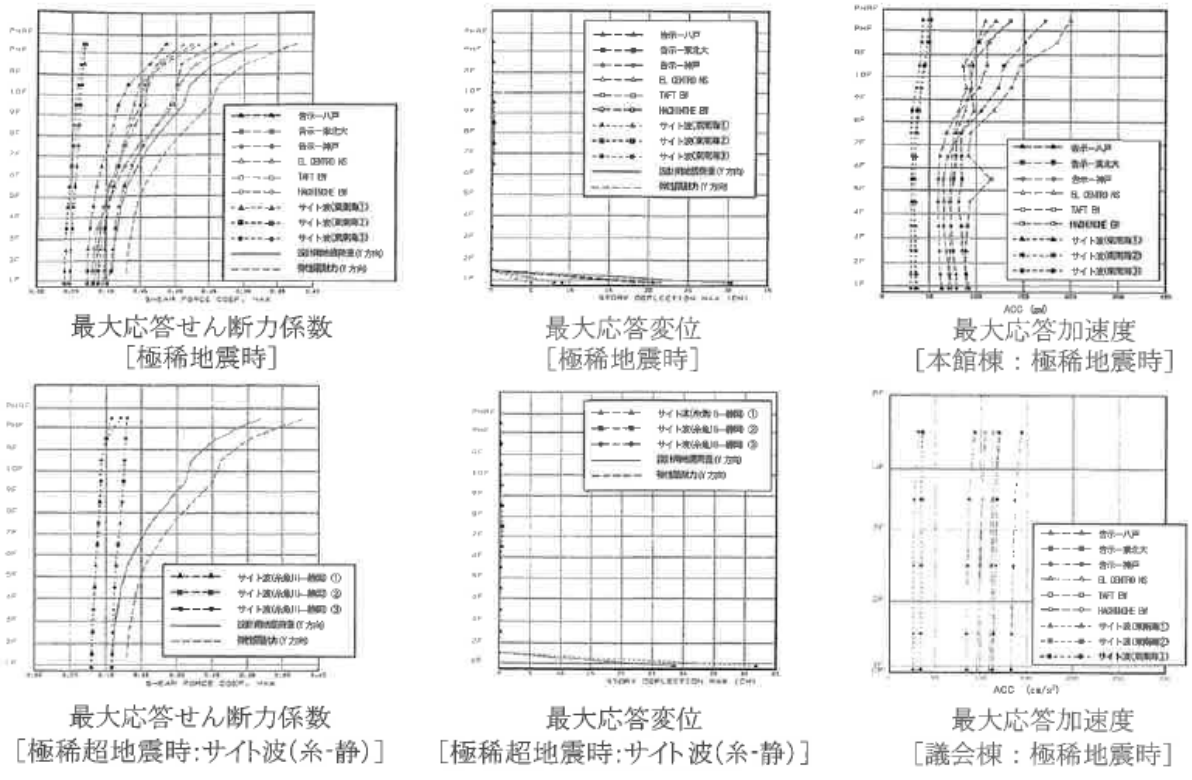
Fig. 3. Results of vibration response analysis (Main Building)

This plan made it possible to secure the necessary seismic capacity for both buildings without any reinforcement of above-ground portions. The result is high-performance seismic isolation, with the lower stories of the Main Building experiencing less than 100 gal floor response acceleration and other occupied floors experiencing less than 150 gal floor response acceleration in a strong earthquake that would occur extremely rarely (Fig. 3).

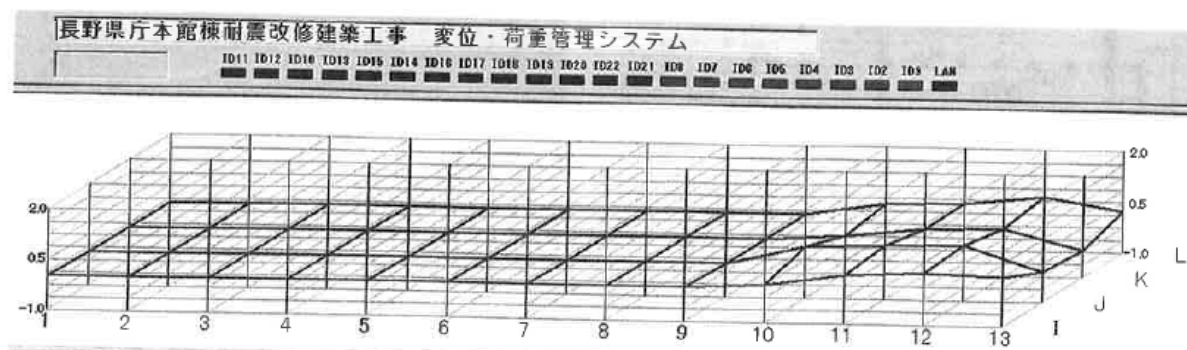
Fig. 5. Accuracy control in the vertical direction (Main Building)

accuracy: less than 1/4,000 in general portions and less than 1/8,000 in the central core of the Main Building, which has a concentration of multi-story shear walls (Fig. 5).

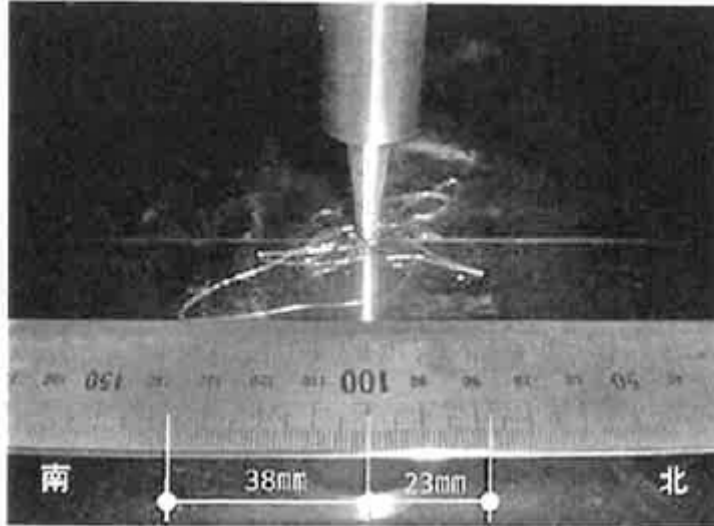
Photograph 2. Marking gauge records (Assembly Building, 2)

At 10:08 PM on November 22, 2014, eight months after completion of the retrofitting project, an earthquake occurred along the Kamishiro Fault, Nagano Prefecture (seismic intensity of IV to lower V). Table 3 shows the seismic isolation deformation recorded by both buildings, and Photograph 2 shows the marking gauge records. The maximum deformation of the base isolation layer was approximately 35 to 39 mm in the Main Building and approximately 40 to 44 mm in the Assembly Building. No damage occurred inside or outside the buildings.
